**UNITED STATES DISTRICT COURT
NORTHERN DISTRICT OF CALIFORNIA**

S.E. and S.F.)	Case No.
)	
Plaintiffs,)	COMPLAINT AND
)	DEMAND FOR JURY TRIAL
v.)	
)	
CHART INC.)	
)	
Defendant.)

II. The Defect in Tank 4

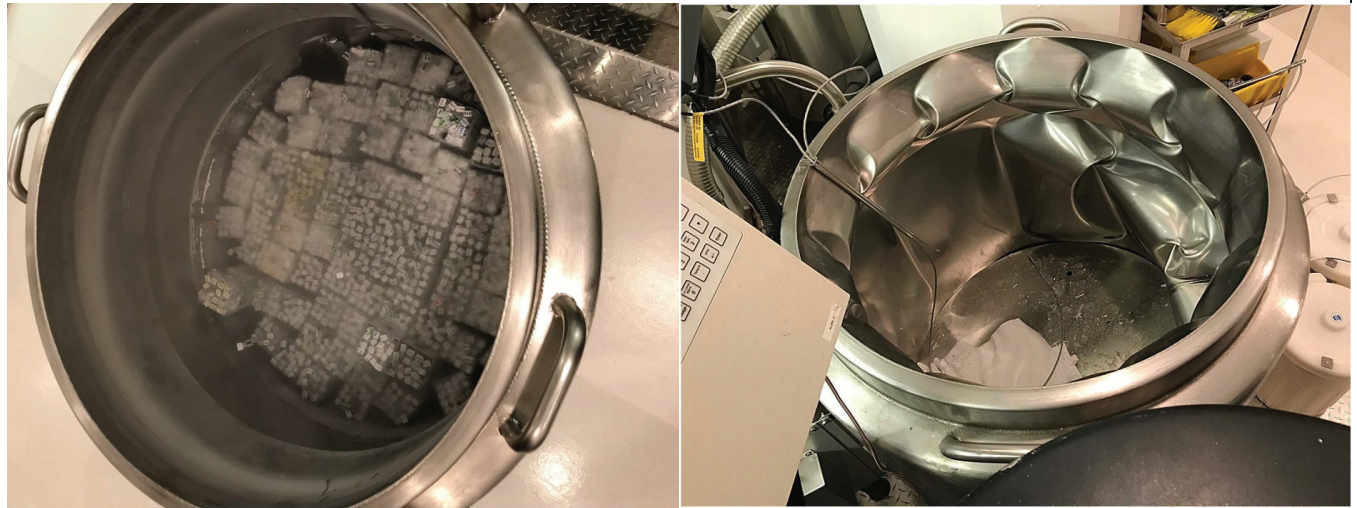
5. The cracked weld also triggered an implosion of the tank's inner vessel, as the liquid nitrogen that was sucked into the vacuum space transitioned to gaseous nitrogen and exerted pressure

on the inner vessel's walls. That is why the lid of the tank was difficult for PFC's embryologists to remove. The imploded tank is shown below, on the right:

Normal Tank

Imploded Tank

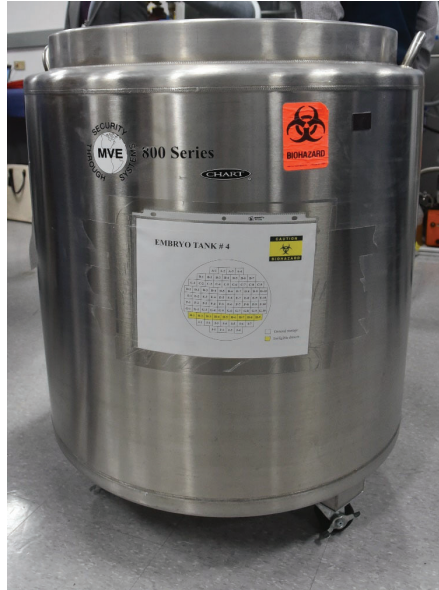
Tank 4

1 15. The tank at issue in this litigation is an MVE-branded cryopreservation tank—
2 specifically, a model MVE 808AF-GB Stainless Steel Freezer, which the embryologists at the Pacific
3 Fertility Center referred to as Tank 4:

15 16. The tank consists of the outer vessel seen above, an inner vessel that can be used to store
16 eggs and embryos in liquid nitrogen, and an insulated vacuum layer that separates the two vessels and
17 prevents heat transfer from the surrounding environment.

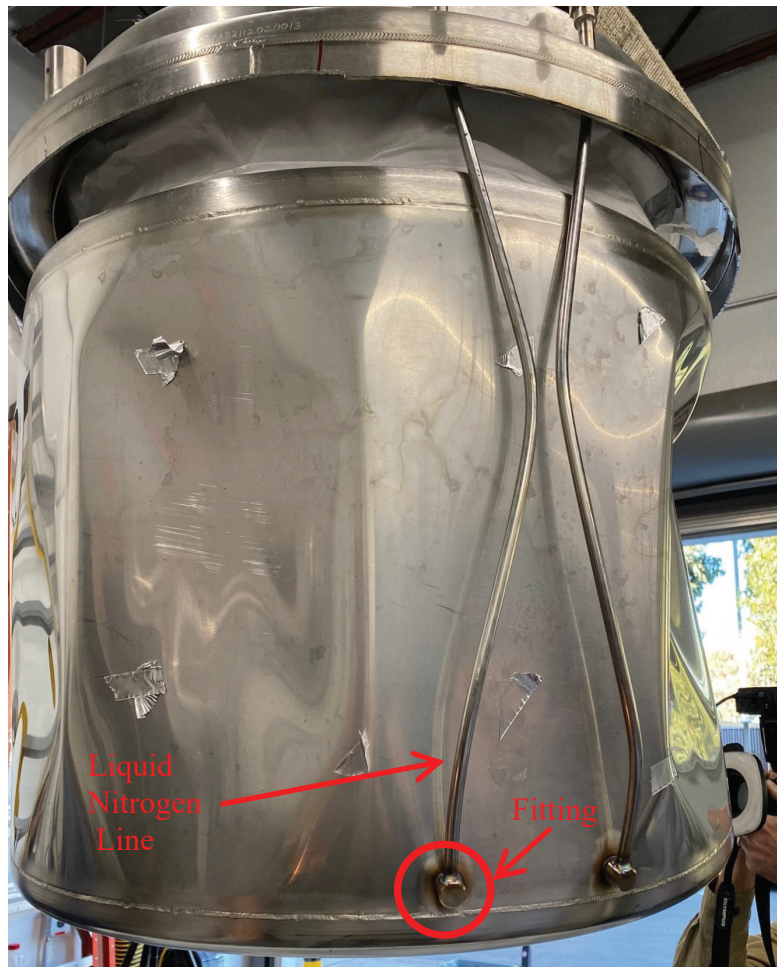
25. The picture below was taken after the outer vessel of Tank 4 was removed. The liquid nitrogen tube is on the left and the red circle shows where it connects to the inner vessel through a fitting.

Liquid nitrogen tube feeds into Tank 4's inner vessel

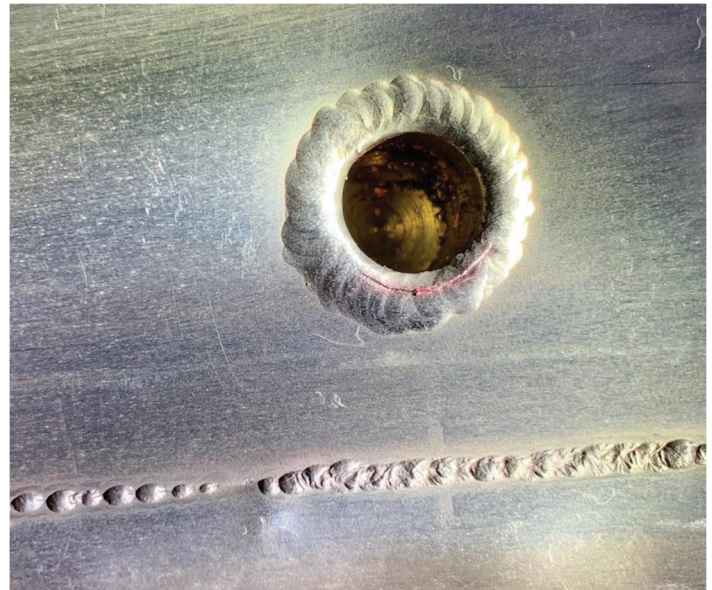
5 27. The image on the right is the same weld, this time after using Magnaflux Spotcheck
6 liquid dye penetrant. The fact the red dye penetrant remained after the surface was wiped clean is
7 indicative of a crack.

21
22
23
24
25
26
27
28
Red dye indicates a crack in the weld

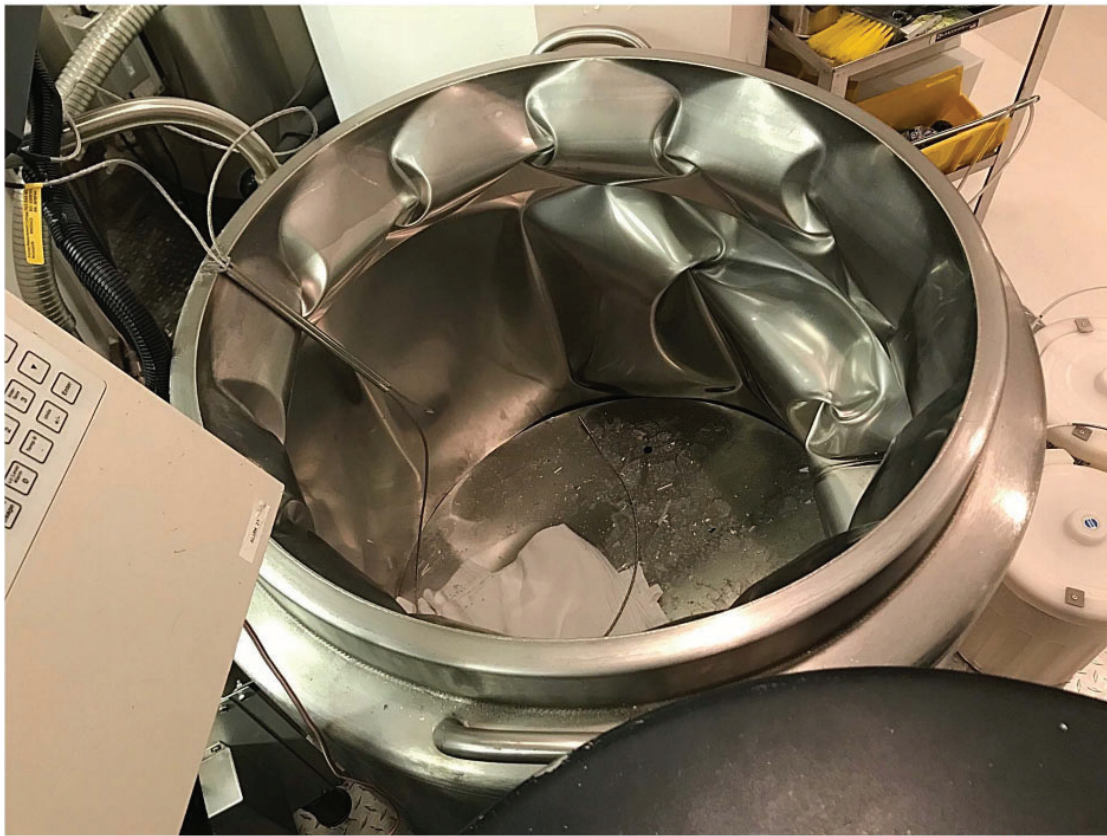
March 6, 2018, 9:03 AM

33. The crack and accompanying leak of liquid nitrogen into the interstitial space both destroyed the vacuum insulation that allowed the inner vessel to stay cold and exerted significant pressure on the space between the tank's inner and outer vessel. The inner vessel gave way and crumpled. The following image was taken approximately 36 hours after the PFC embryologists discovered the Tank 4 failure and moved the affected eggs and embryos to another tank.

Tank 4 after the incident

34. This dramatically imploded tank is yet another indication of a cracked failure. As part of its compliance with the European Union's Medical Device Directive, Chart was required to attempt to identify every way that its cryogenic freezers could theoretically fail. Representatives from Chart's various departments came up with over a hundred potential failure modes. One of them was a cracked weld at the liquid nitrogen fill tube—exactly what expert analysis revealed happened to PFC's Tank 4. If that weld did crack, Chart wrote that the result would be: "Liquid draws into vacuum space, expanding rapidly and causing an inner vessel implosion, total vacuum loss. Loss of function of the freezer."
